**REGULAR MEETING AGENDA
PAJARO DUNES GEOLOGIC HAZARD ABATEMENT DISTRICT
HYBRID MEETING in person at**

**Board Room
2661 Beach Rd.
Watsonville, CA 95076**

Saturday, August 5th, 2023 9:00 a.m.

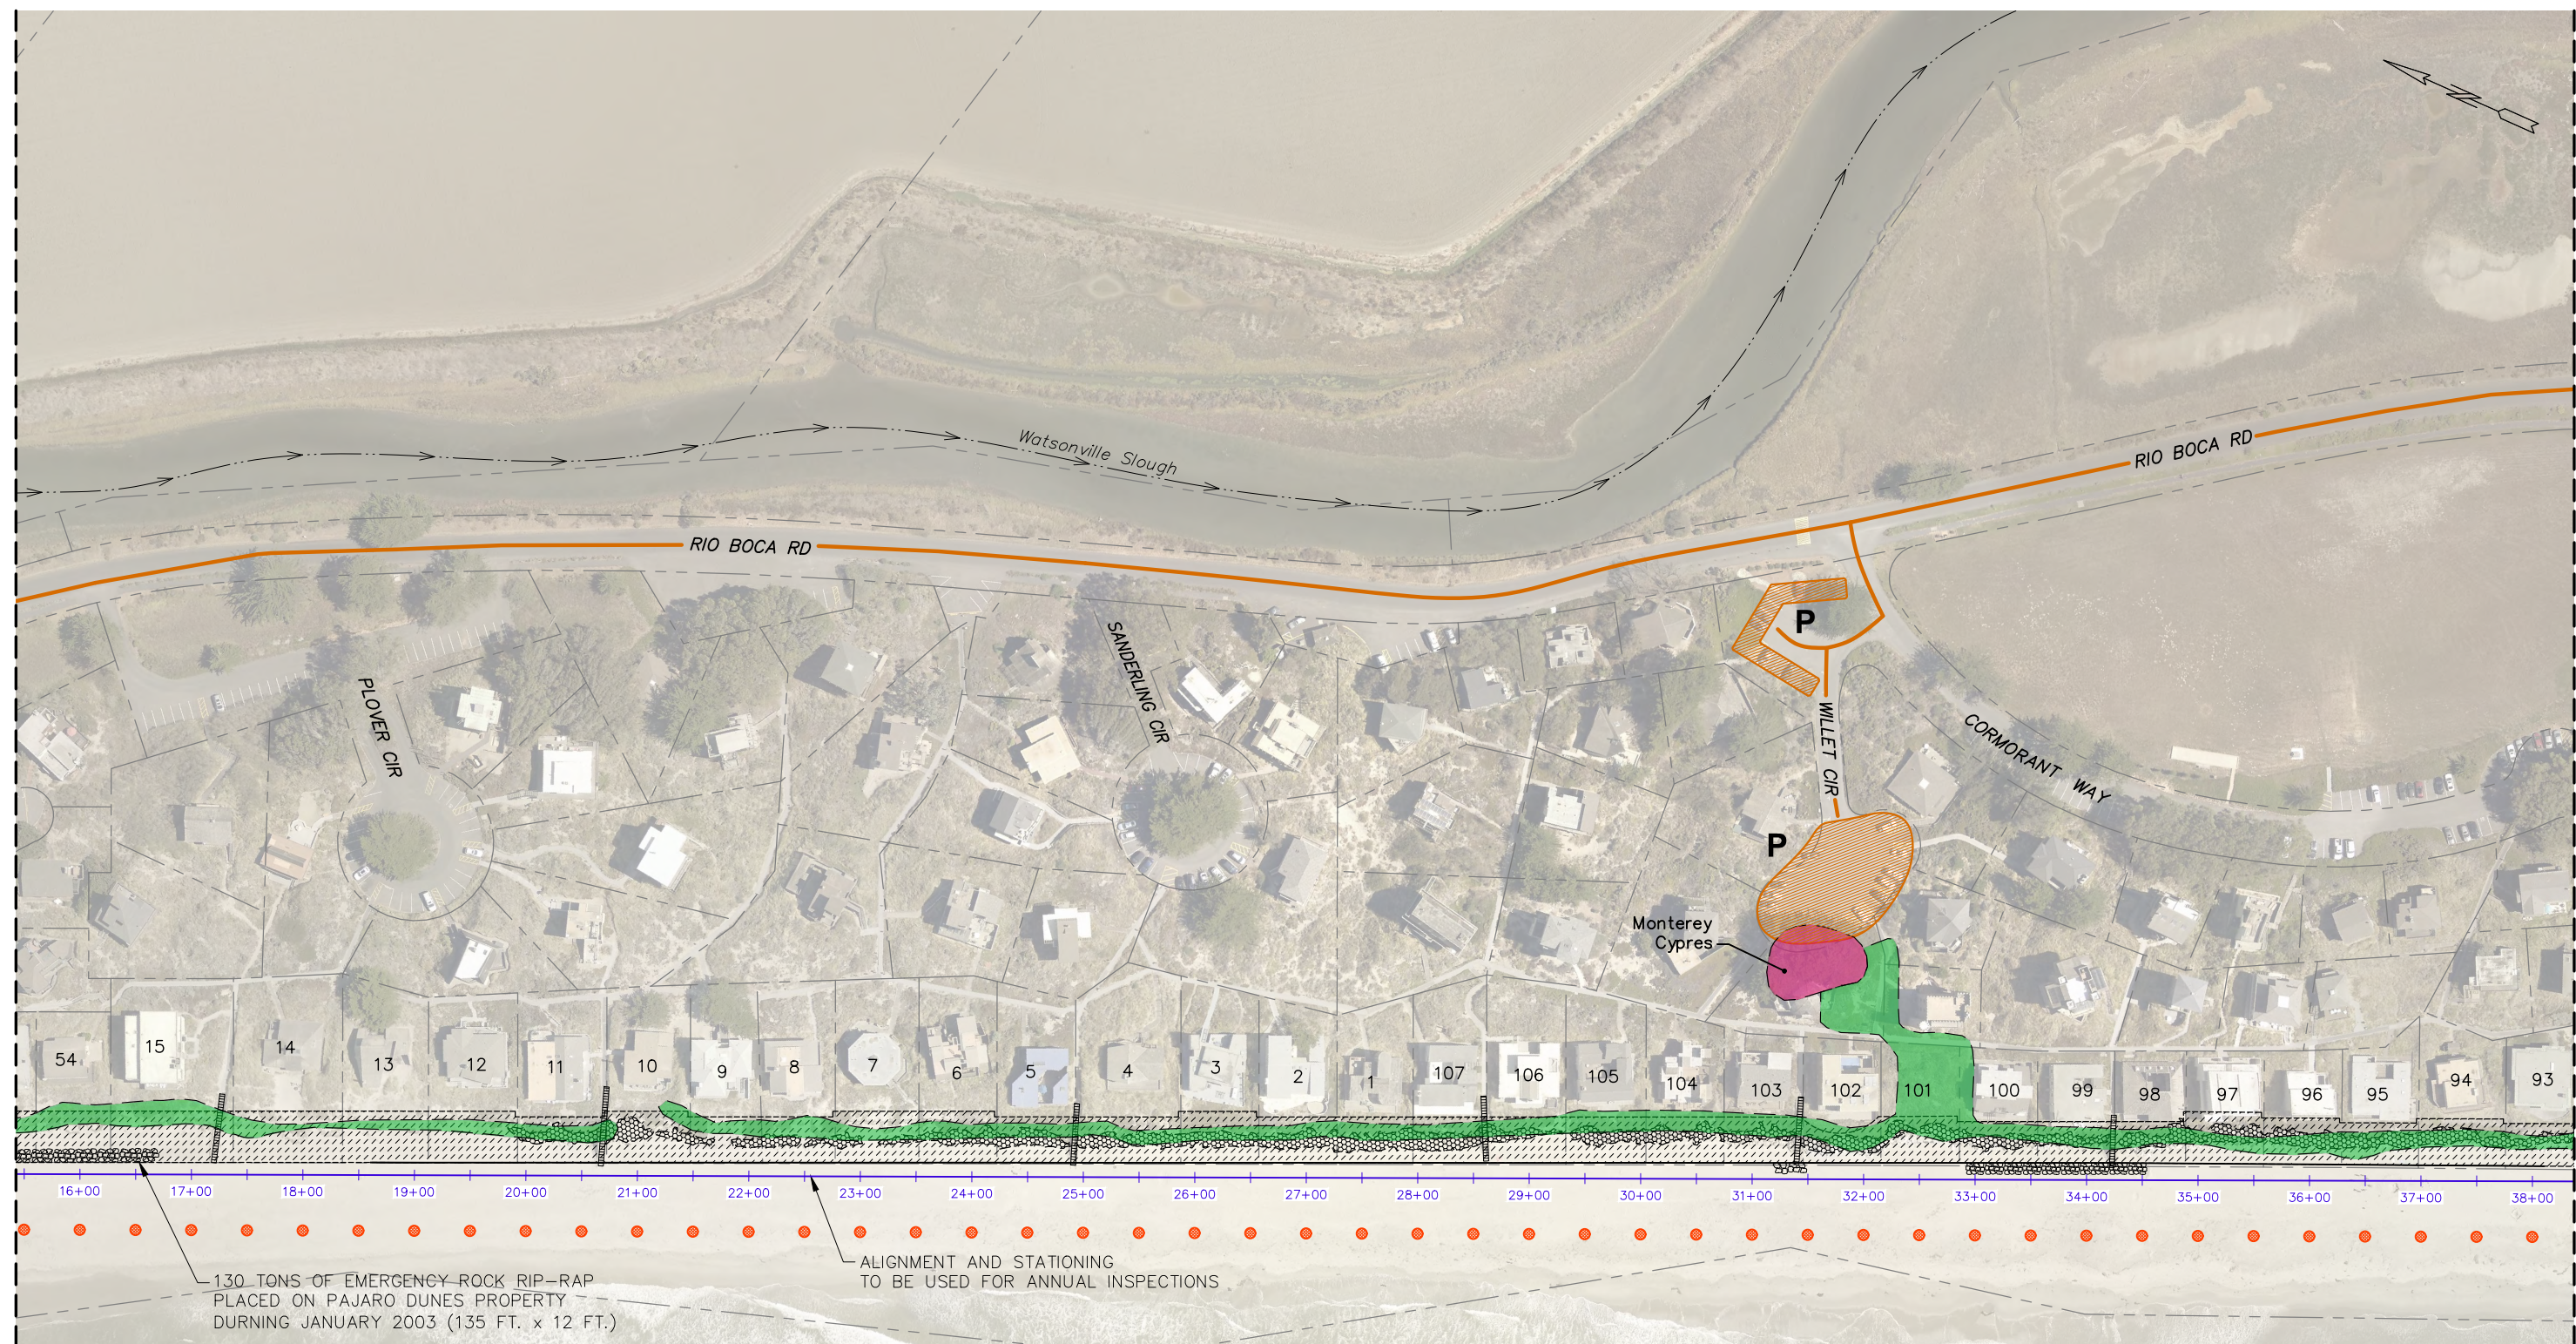
130 TONS OF EMERGENCY ROCK RIP-RAP PLACED ON PAJARO DUNES PROPERTY DURING JANUARY 2003 (135 FT. x 12 FT.)

ALIGNMENT AND STATIONING TO BE USED FOR ANNUAL INSPECTIONS

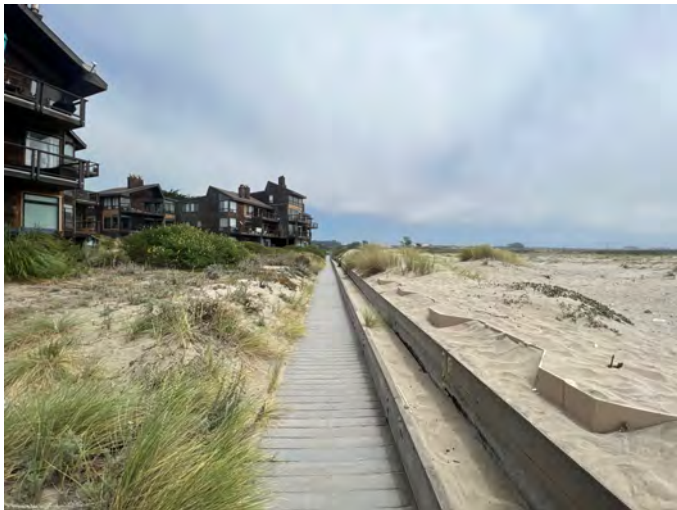
Photo 80.5: Sheetpile wall south of Pelican Drive - Complex C

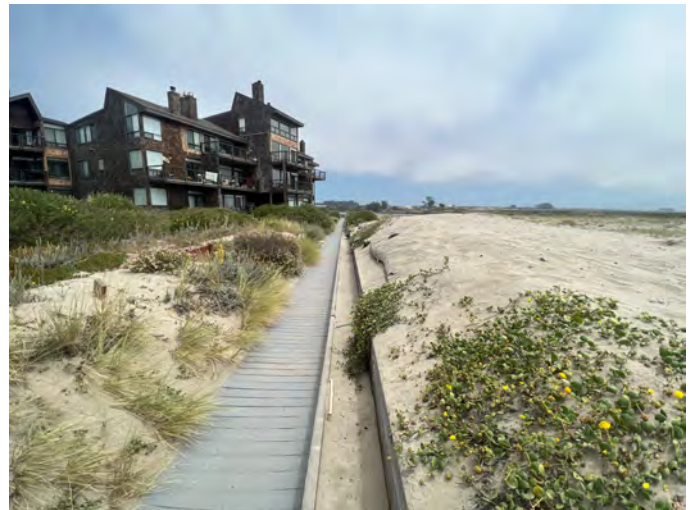
Photo 81: Sheetpile wall south of Pelican Drive - Complex C & D

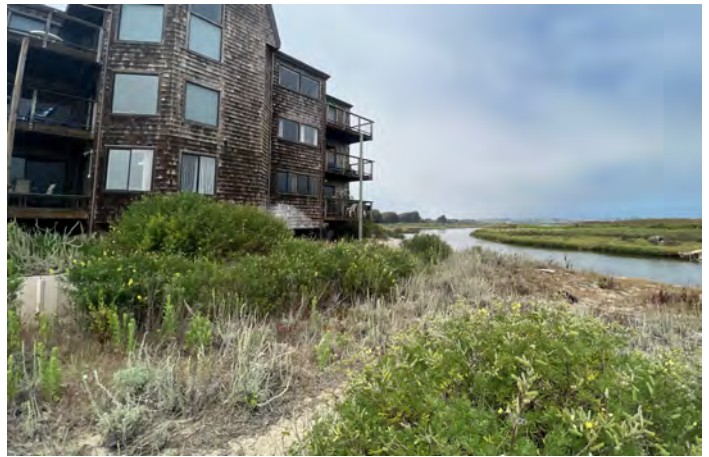
Photo 84: Sheetpile wall southeast of Pelican Drive - Complex E

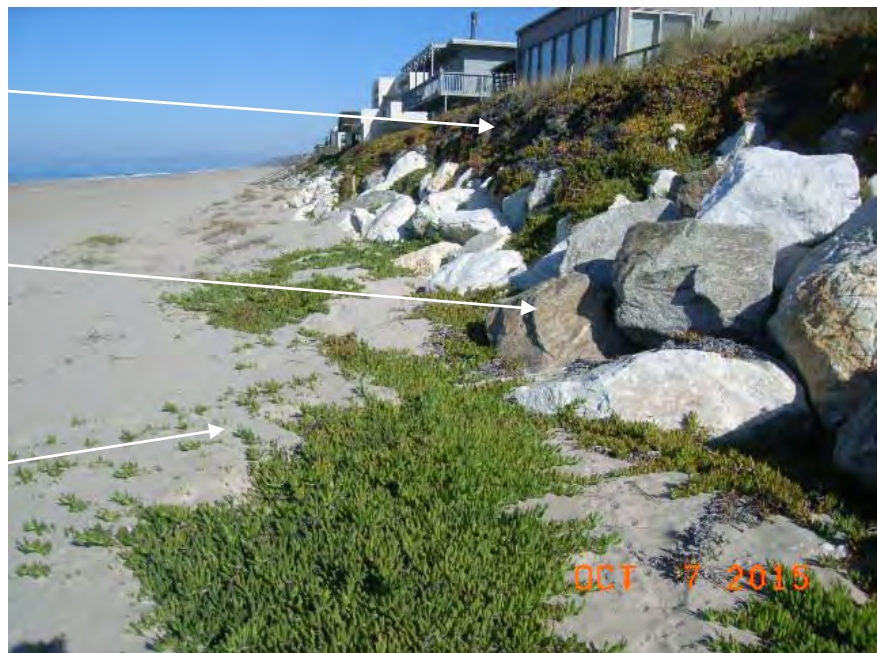
Figure 5. View of revetment repair project area, looking north from Lot 94, October 2015.

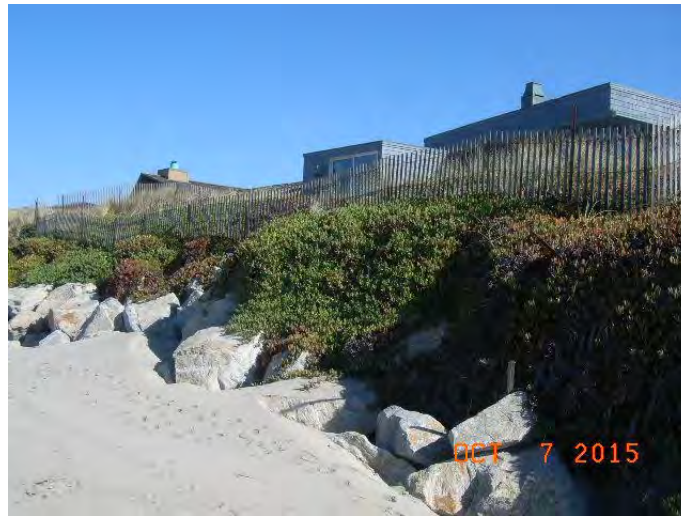
Figure 6. View of dune vegetation (dominated by iceplant) along top of revetment on Lot 3; looking north from beach, October 2015.

The foredunes within the revetment repair work areas (adjacent to residences) support areas of dune scrub. This dune scrub vegetation is dominated by non-native species such as European dune grass (*Ammophila arenaria*) and iceplant (*Carpobrotus sp.*). Other species include sea rocket (*Cakile maritima*), myoporum (*Myoporum sp.*), bur clover (*Medicago polymorpha*), slender-leaved iceplant (*Mesembryanthem nodiflorum*), cat's ear (*Hypochaeris sp.*), and rigput brome (*Bromus diandrus*), as depicted in Figure 6.

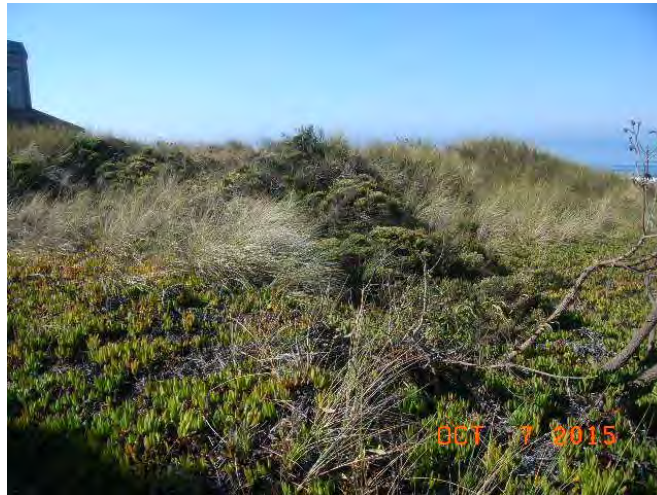
Figure 7. View westward from Willet Circle to beach, showing potential construction access area through Lot 101, October 2015.

Figures 7 through 10 depict the vegetation along the four potential proposed construction access ways.

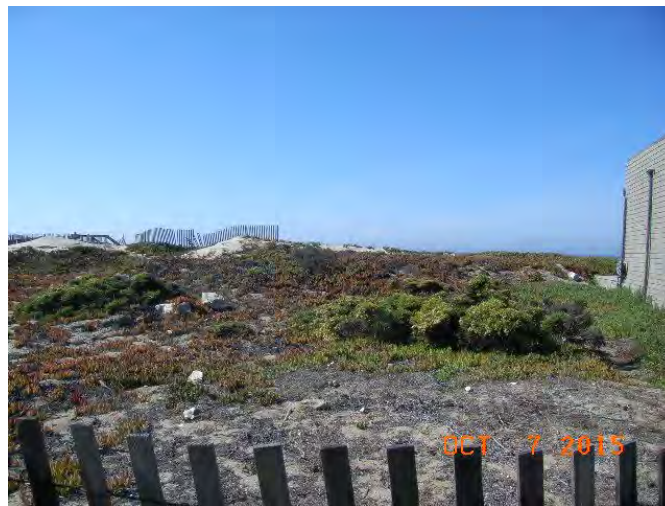
Figure 8. View westward from Puffin Lane to beach, showing potential construction access area through Lot 141, October 2015.

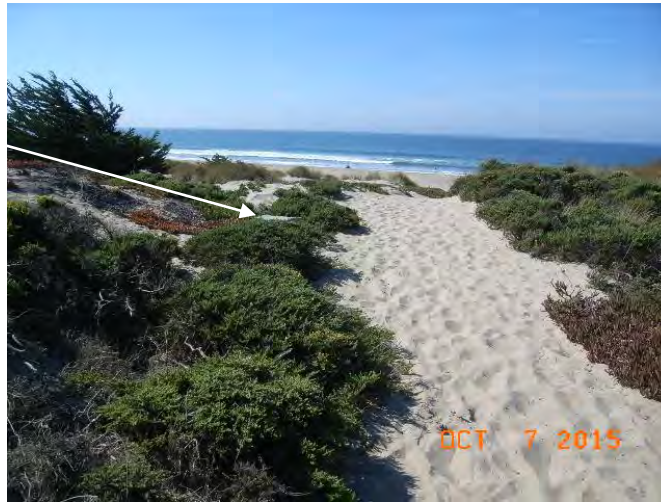
Approximate location of colony of Monterey spineflower in 2008, 2013, and 2015

Figure 9. View westward from along West Beach Road right-of-way to beach, showing proposed construction access area and colony of Monterey spineflower, October 2015.

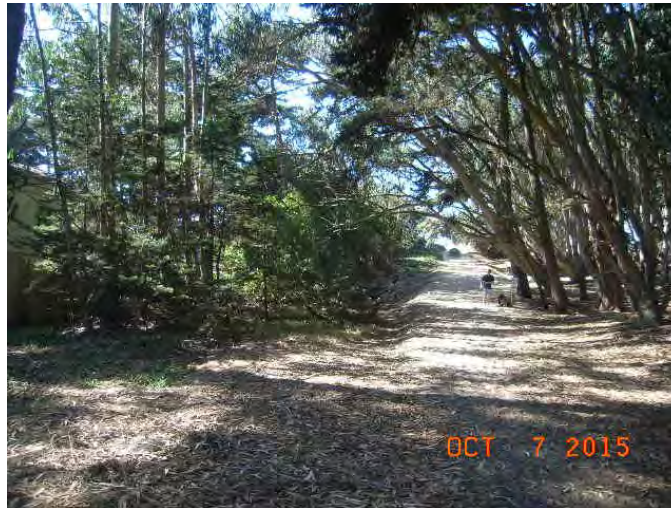
Figure 10. View westward along West Beach Road right-of-way to beach, showing potential construction access within eucalyptus and cypress tree groves, October 2015.
